Manhole Inspection Summary

Manhole # S33S__006MH

Insp Date: **8/15/08 11:52 AM**

Location Address: **leadenhall st**

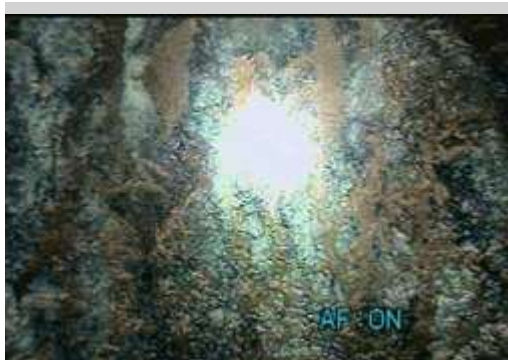
Defect 4

Infiltration: ☐ None ☐ Joint ☐ Cracks ☐ Mortar ☐ Roots ☒ **Wall**

infiltration in barrel

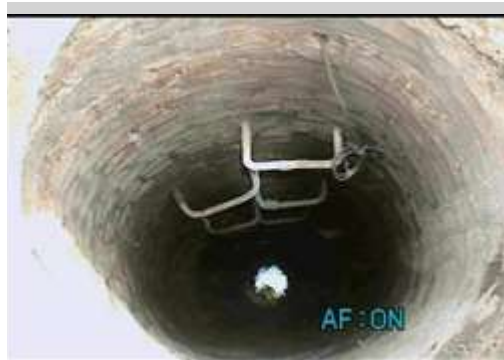
Defect 3

Steps Count: **10** Missing: **0** ☒ **Corroded**

steps

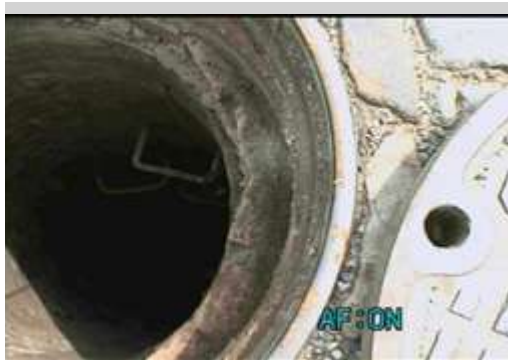
Defect 2

Frame Offset: **3** (in.) Condition: ☒ Sound ☐ Cracked ☐ Leaks

offset

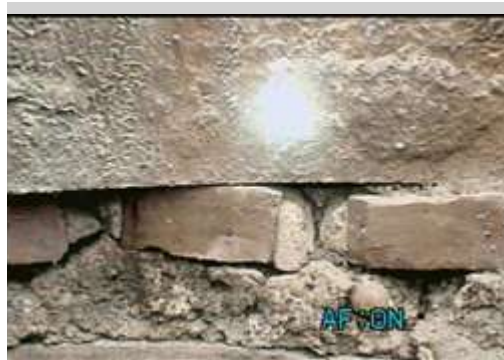
Defect 1

Condition: ☐ Sound ☐ Cracked ☐ Root Intrusion ☒ **Loose Brick** ☒ **Deteriorated**

chimney loose bricks, deteriorated, frame adj

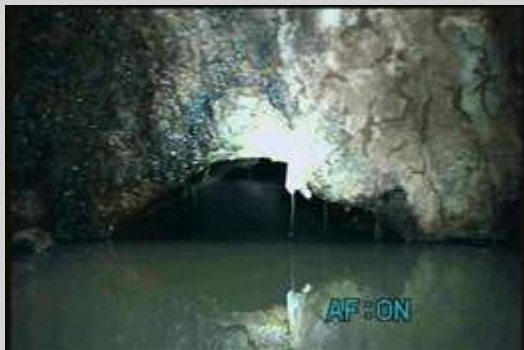
12 O'Clock Outflow

27 in. Circular Gravity Sewer
Pipe Out @ 12 O'Clock

Invert Depth: **18.75** (ft.) Flow Characteristics: **Slow**

Infiltration: **None** Pipe Seal Cond: **Unknown**

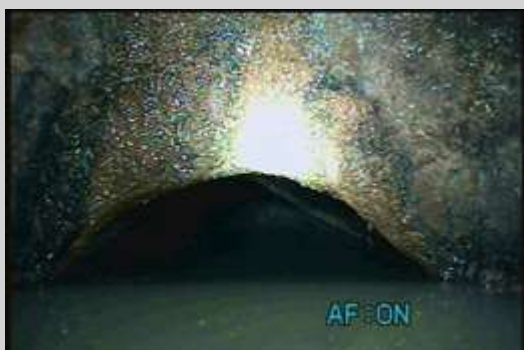
6 O'Clock Inflow

27 in. Circular Gravity Sewer
Pipe In @ 6 O'Clock

Invert Depth: **18.58** (ft.) Flow Characteristics: **Slow**

Infiltration: **None** Pipe Seal Cond: **Unknown**
